SOUND URBAN FORESTRY, LLC

4/30/18

RE: Greenfield Street Tree Evaluation and Management Recommendations

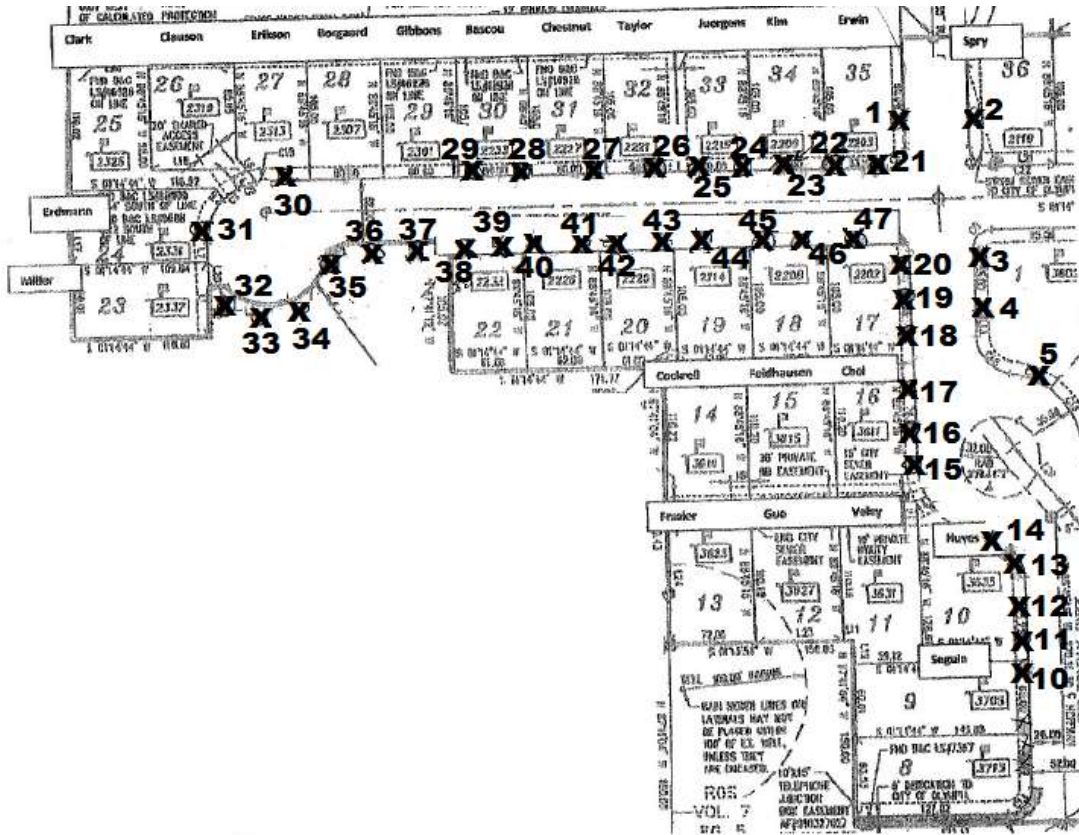
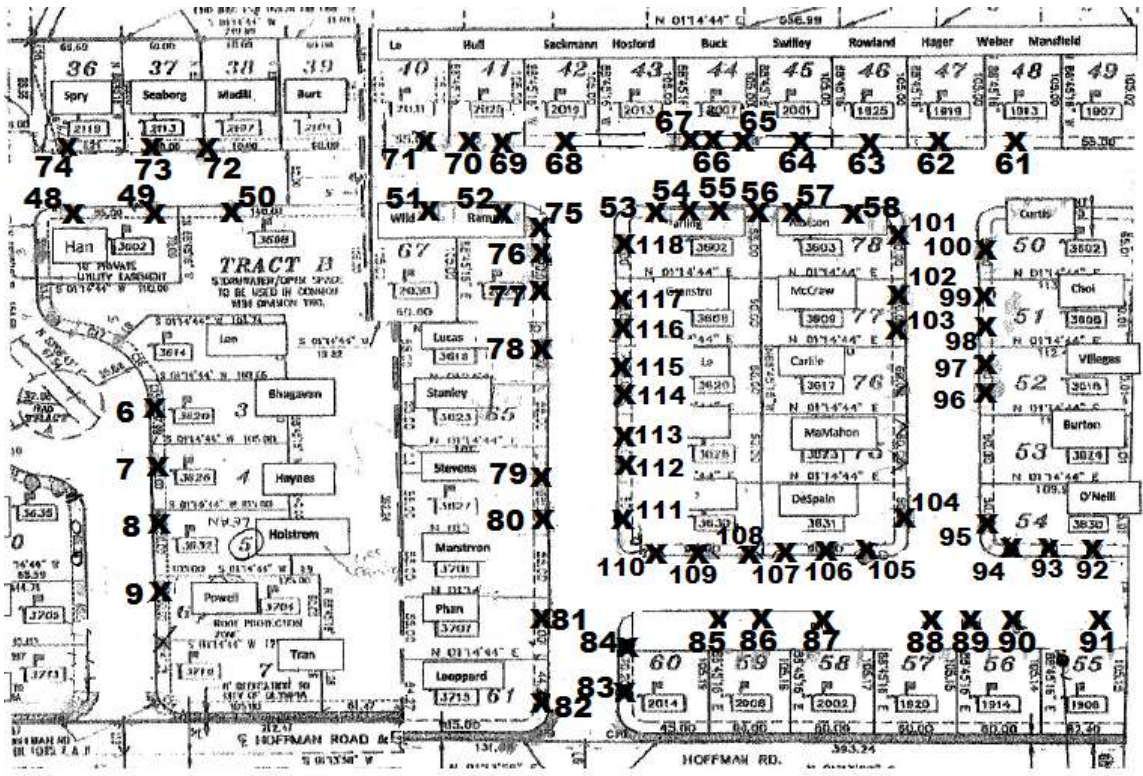
Locations of Identified Trees

The following trees were identified and are located on the included site maps.
